AFFIDAVIT

# Epsilon E-Steer Sensor History of Furukawa Slip Ring Plating Change

- Action Title: Slip Ring Plating Analysis Report
- Start Date: 14JA04
- End Date: 11FE04
- Brief Summary:
  - Material analysis of slip rings and contact brushes on samples from warranty, virgin production, and column validation (PV3) wear life testing.

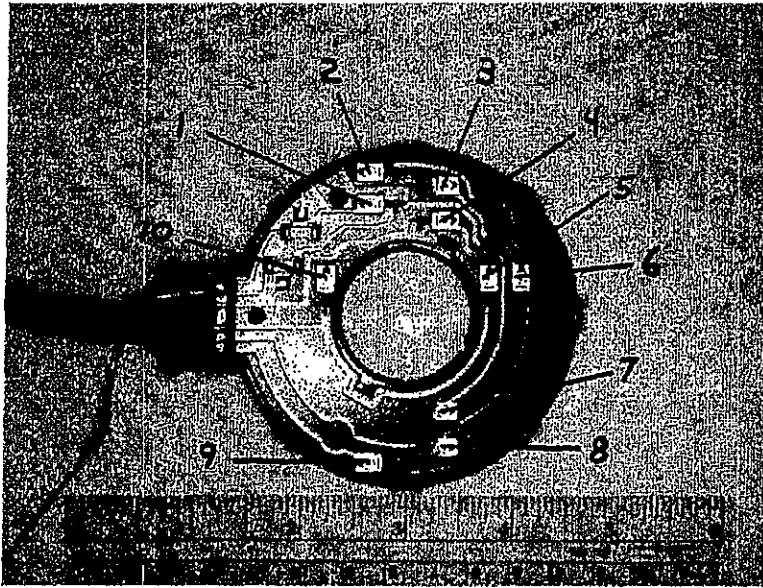
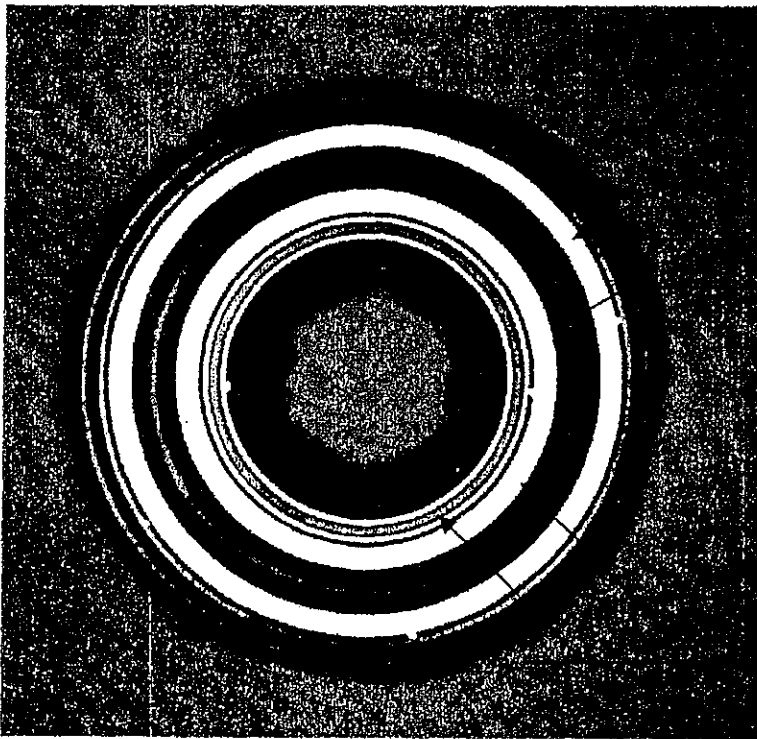
Figure 1a) A low magnification view of the contact layout for the position measurement side of the steering sensor

Figure 1b - A similar low magnification view of the PC board layout that mated to the contacts shown in figure 1a. In the original Delphi print-  
Ring 1 = T1 slip ring  
Ring 2 = GND slip ring  
Ring 3 = P1-P2 resistor ring  
Ring 4 = VCC  
Ring 5 = T2 slip ring

Figure 1- Low magnification photomicrographs of the field returned unit after dis-assembly to show the contacts and PC board for the position monitoring portion of the steering sensor.

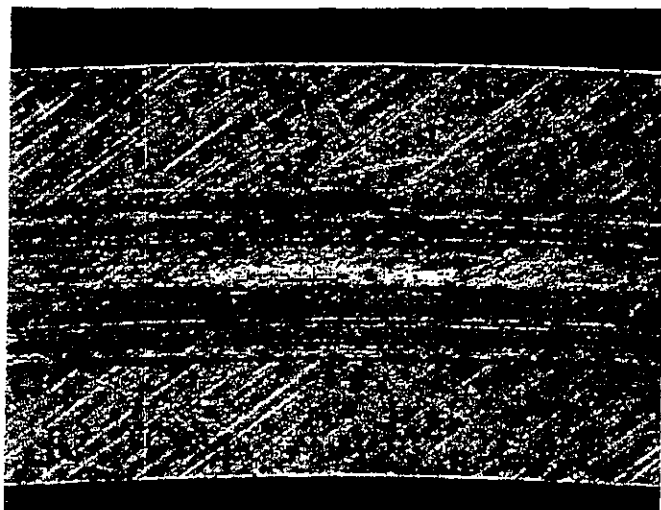
Figure 2 shows low magnification photomicrographs of the Au (track 2) ring from each of the sensors. Both the unused (virgin) sample and the field return from current production show a mottled surface appearance. The wear tracks from the brush contacts are seen on also evident on the PV and field return sample. Figure 3 shows a region from the PV sample where a dark streak was seen on the edge of the wear area. This area was marked for additional SEM analysis. Figure 4 shows three other similar views from the two Au rings on the field return sample. Combined with the region shown in figure 2a, these are the four points on the rings where the contacts were located when the noise event was detected ( as marked by Delphi Saginaw). Some of these areas show a slight difference in surface reflection, and all four spots were marked for additional SEM examination.

Figure 2a -  
Field return sample  
Track 2, position on  
track mated to contact 8  
at "noisy" rotor location

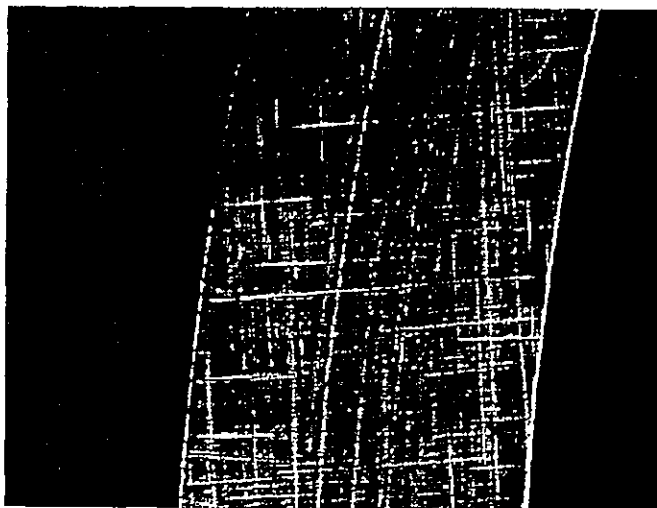
Figure 2c)  
PV sensor  
Track 2,  
random location

Figure 2- Low magnification photomicrographs  
showing the surface finish on the Au plated rings  
for the three sensors supplied by Delphi-  
Saginaw.

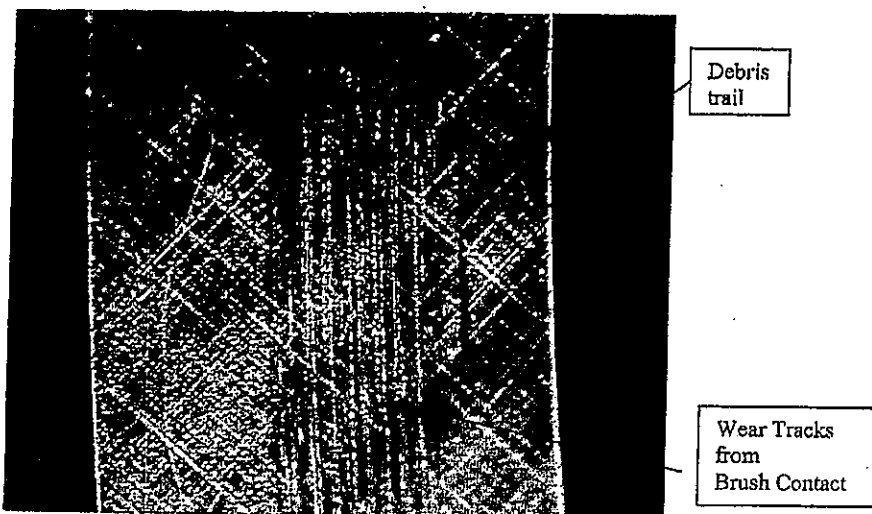
**Figure 3-** A low magnification photomicrograph taken at another location on track 2 of the PV sensor illustrating some built up wear debris adjacent to the wear track created by the nine wire contact.

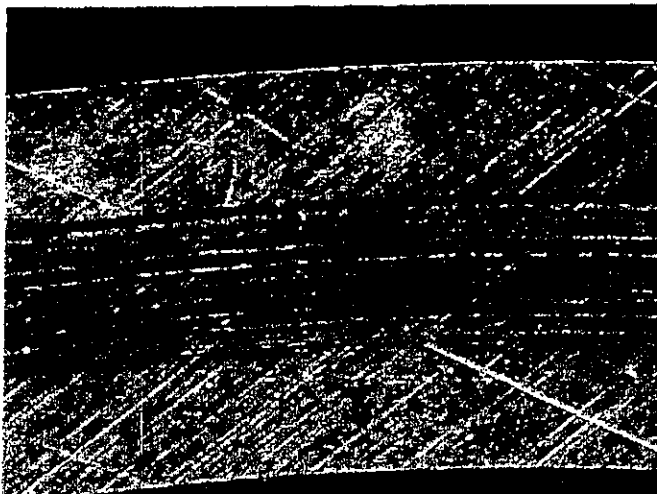
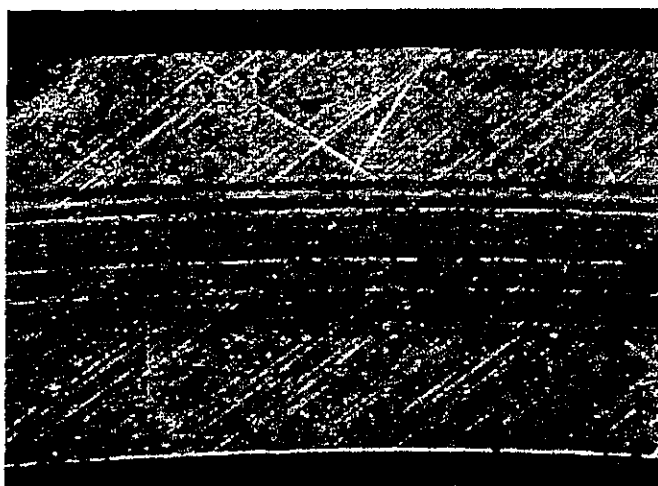
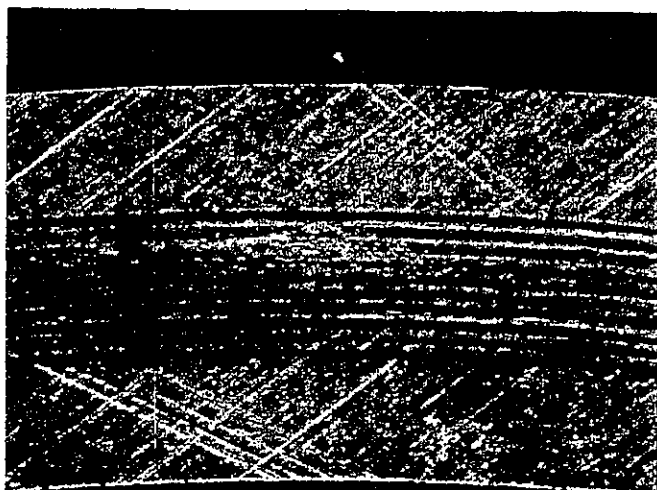
Figure 4 a  
Track 4  
marked location  
for contact 7  
at noise event

Figure 4 b  
Track 2  
marked location  
for contact 3  
at noise event

Figure 4 c  
Track 4  
marked location  
for contact 4  
at noise event

Figure 4 – Low magnification  
photomicrographs showing the Delphi  
marked regions on the Au rings where the  
contacts resided at the noise event

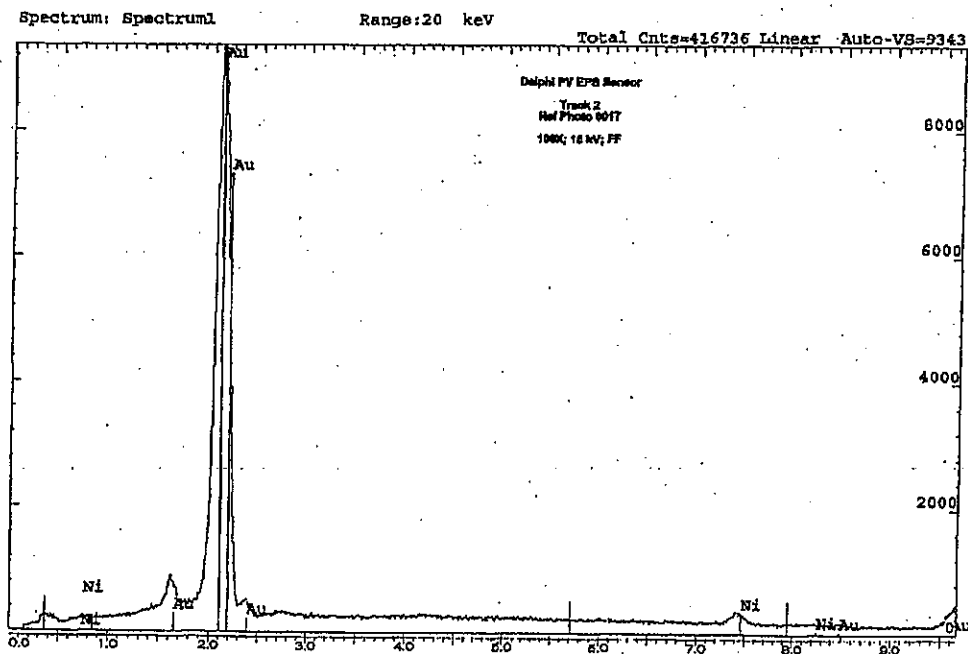
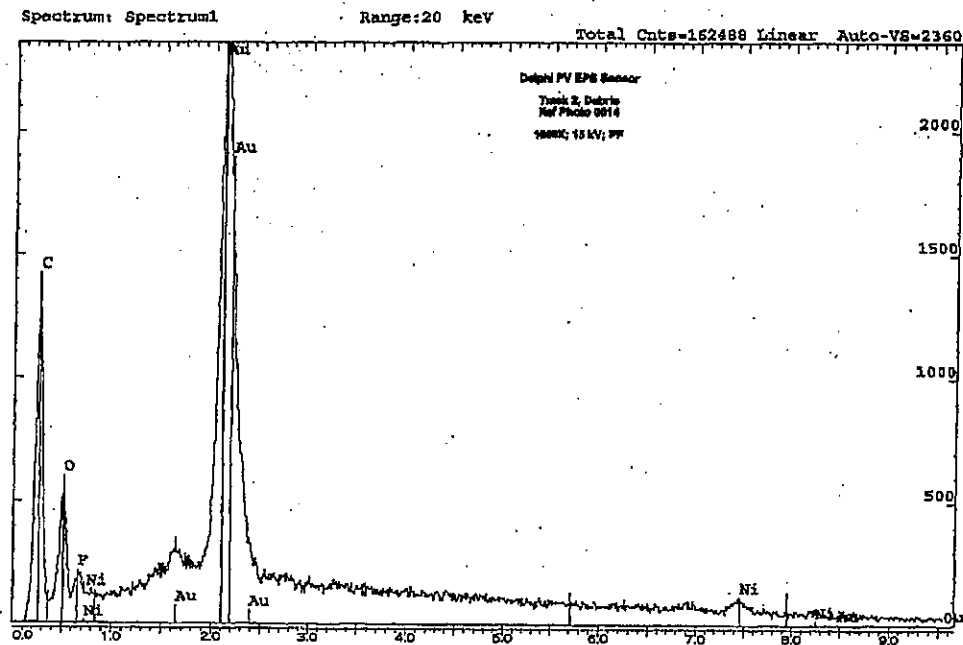
Figure 5 shows two SEM photomicrographs and the associated surface x-ray spectra from the PV sample. Figure 5a and 5b are from an area similar to that seen in figure 2c, and show a uniform level of Au with some shallow wear tracks from the brush contacts. Small Ni peaks are seen in the x-ray spectrum. Since the plate was reported to be Au over Ni over Cu. The small Ni peaks suggest the 15Kv accelerating potential used for this analysis has penetrated through the Au layer and excited a small amount of x-rays from the subsurface Ni barrier level. The second SEM photomicrograph (5c) and associated x-ray spectrum (5d) are taken from a region similar to figure 3. In addition to the Au and Ni seen in figure 5b, there is also evidence of C, O and a small amount of F. The most likely source for this a residue from a fluorocarbon based lubricant.

Figure 5a - SEM photomicrograph of the Au plated region on track 2 from the PV sensor

Figure 5 b- X-ray spectrum from the surface of track 2 on the PV sensor.

Figure 5c-  
SEM photomicrograph  
of the dark streak shown  
in figure 3

Figure 5d  
X-ray spectrum  
from the dark streak  
shown in figures 3  
and 5c.

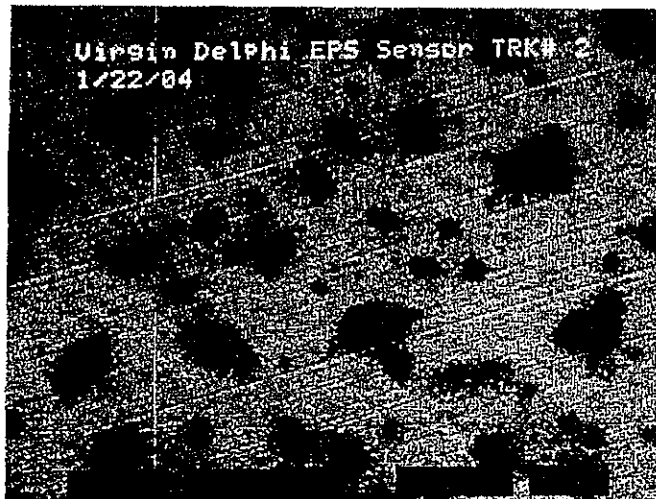
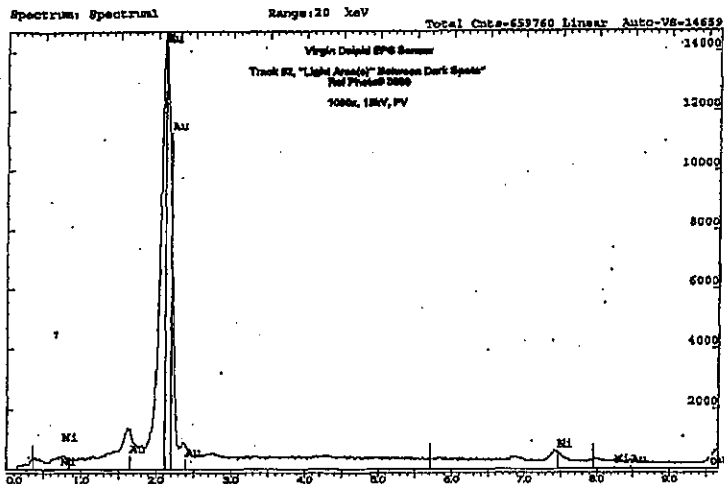
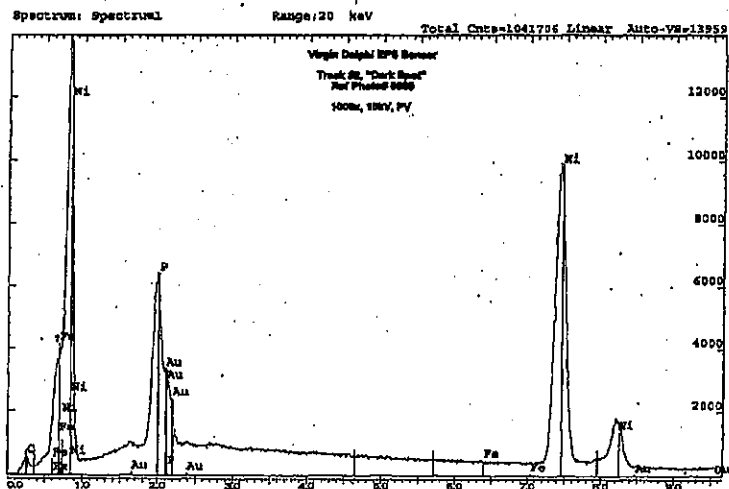
Figure 7 – A higher magnification SEM photomicrograph of the surface of a Au plated ring from the current production, virgin sensor.

Figure 8a -X-ray spectrum typical of one of the lighter areas in figure 7.

Figure 8 -X-ray spectrum typical of one of the darker areas in figure 7.

Figure 8 X-ray spectrum from the light and dark areas of figure 7. Similar elemental surface chemistry results were found on the Au plated rings in the field return sensor.

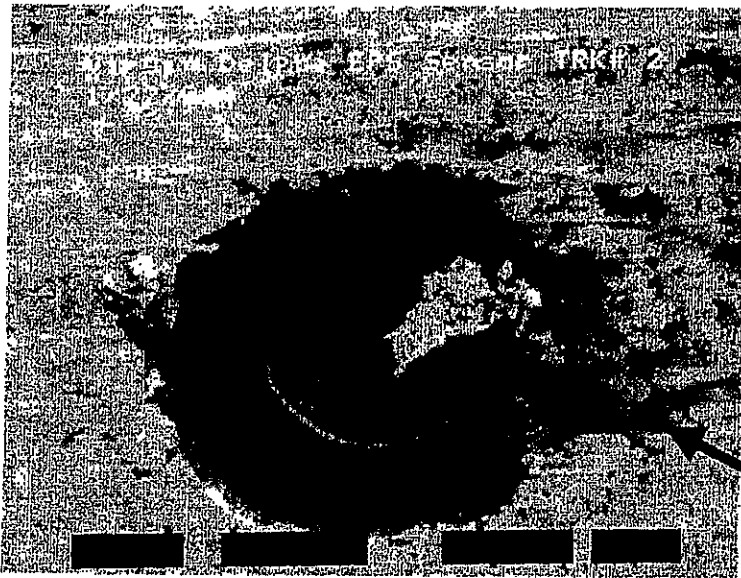
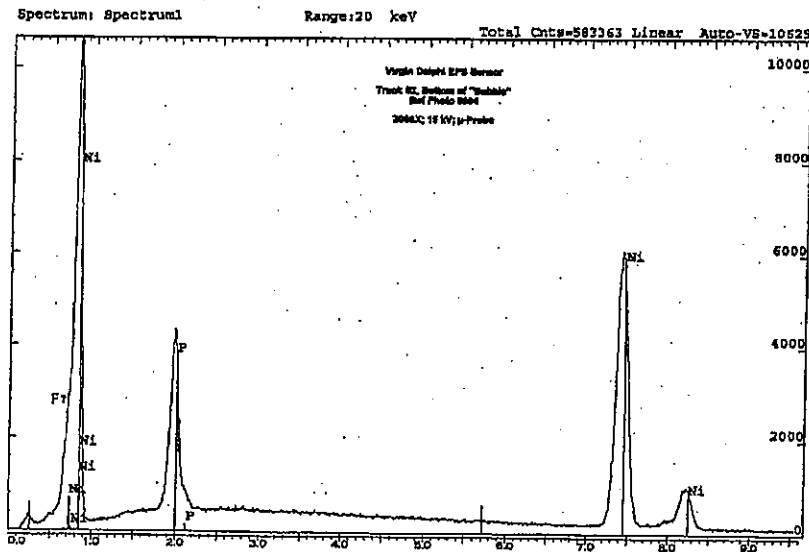
Figure 9a

Likely original site for  
large flake before it  
"rotated" loose

Figure 9b X-ray spectrum  
from the center of the  
circular spot shown in 9a.

Figure 9 SEM photomicrograph and X-ray spectrum form a circular dark regions on the surface of track 2 from the "virgin", current production sensor.

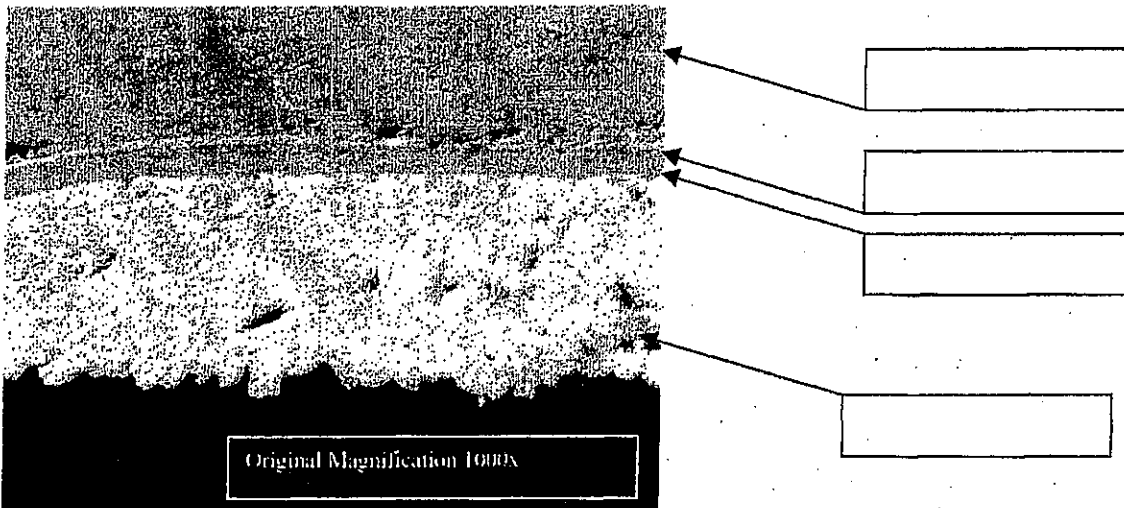
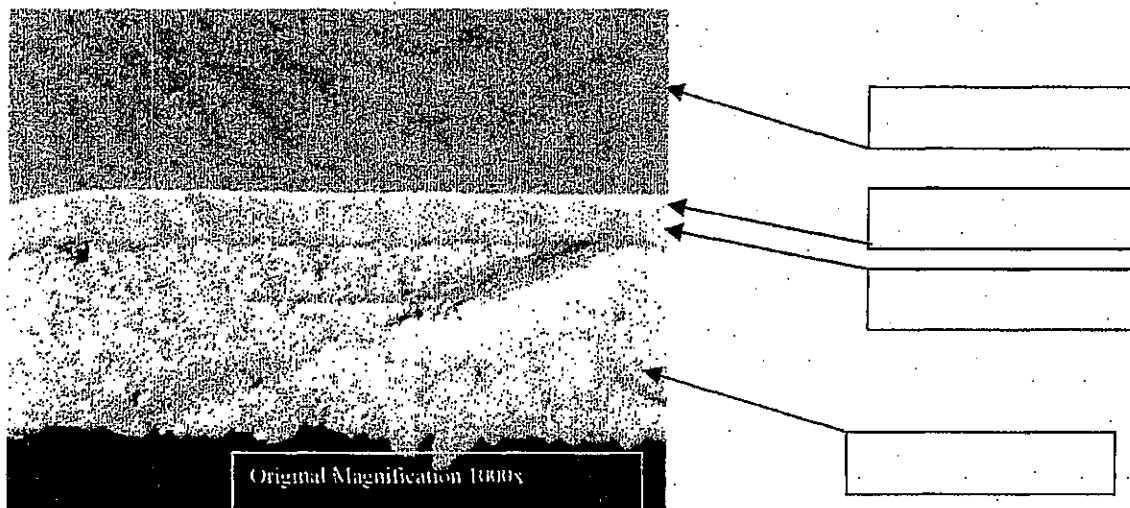
Although no evidence was found to directly associate these features with the current field problem, they are highlighted because they offer the potential for creating future noise problems. The reason for using a gold plated surface in an electrical contact application is that Au does not tarnish or oxidize. Therefore, Au plated surfaces will provide low and stable contact resistance over a wide range of applications and environments. However, it has also been documented that defects in the Au plate can lead to erratic contact resistance performance. Perhaps the most studied defect is porosity exposes the Ni underplate to the service environment. Past studies (references 1-4 in the appendix) have shown that both pore corrosion and creep corrosion are possible, depending on the environment. Pore corrosion can be thought of as a small defect that exposes the Ni underplate, and the resultant chloride and sulfate corrosion products mirror the size of the pore. In creep corrosion, the corrosion products actually begin to "creep" over the surface of the Au plate and actually increase the size of the high resistance spot (well beyond the size of the initial pore). Since both products only require exposure of the Ni underplate and ppm level concentrations of Cl and S vapors, it is likely that these phenomena would be active in the sensor. Based on the SEM photomicrographs shown in figures 6 and 7, somewhere between 15-30% of the overall surface is exposed Ni, and susceptible to this type of signal degradation. It should be noted that these phenomena are generally studied under static or stationary contacts- and it is not known how the kinetics are influenced by the continuous wiping anticipated for the sensor. In contrast, figure 5 shows the PV sample to have a continuous, pore free Au electroplated layer.

Figure 11a- Cross sectional view of the plated structure found on the field returned sample. Note irregular thickness and "zero coverage" areas in the Au layer.

Figure 11b- Cross sectional view of the plated structure found on the PV sample. Note uniform thickness and complete coverage for the Au layer

Figure 11 Cross sectional views of the plated structure found on both the field return and retained PV samples.

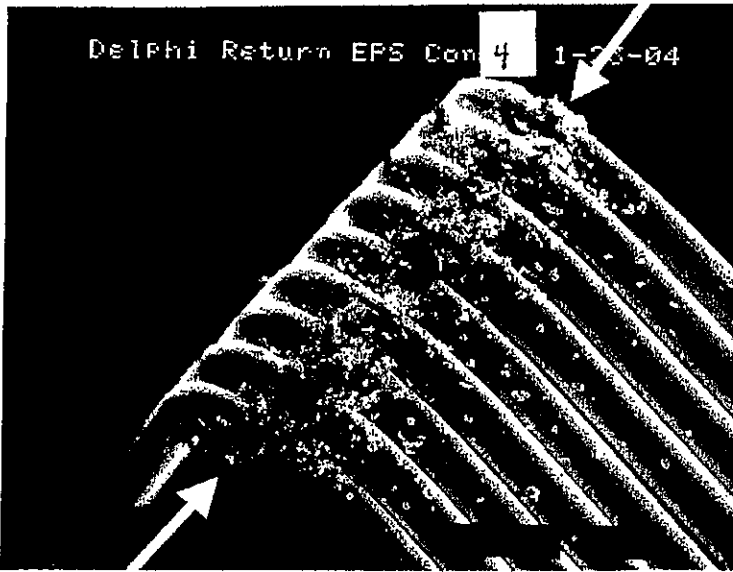
With this in mind, the sliding contacts of the field return sensor were examined in the SEM. Figure 13 shows the debris build up around two set of contacts. The point of physical and electrical contact to the ring appears to be a somewhat "cleaner line" running down the center of the debris pattern. The debris appears to be a combination of large flakes and compacted debris. Additionally, a large number of smaller flakes can be seen attached to the wires outside the contact region. These flakes were found to be similar to the flakes found on the PC board. Figure 14 shows various x-ray spectra from this debris. The debris is found to vary from: 1) nearly pure Au (14a) to 2) a mixture of Au plus F (14b note the absence of the C peak expected for PTFE) to 3) a more complex mixture (14c) showing evidence of the wire (Pd, Ag, Cu) plus the Au plate plus other elements from either the PTFE in the plate or an external lubricant (C, O and F).

Figure 13b – SEM photomicrograph of contact 4 taken from the field returned unit. The white arrows show the contact area that mated to the Au plated ring

Figure 13- SEM photomicrographs of two wire microbrush contacts from the field returned sensor. Note the high volume of flakes and compacted debris on both the leading and trailing edges of every contact.

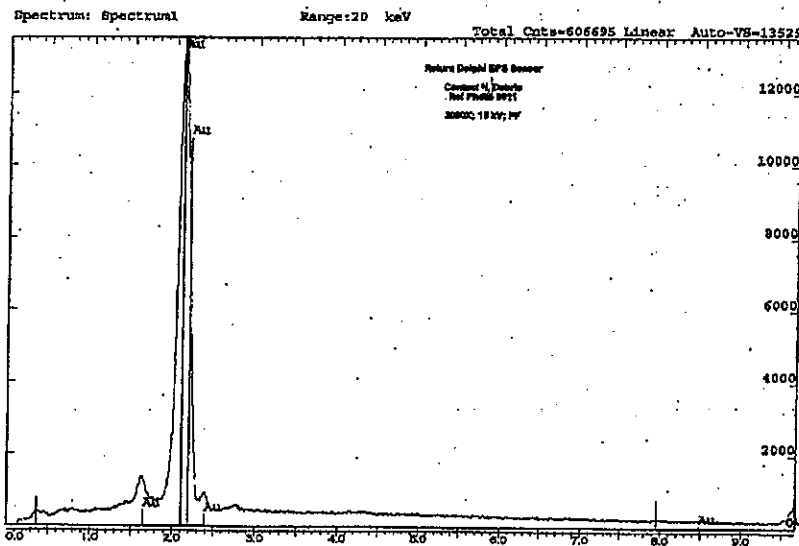
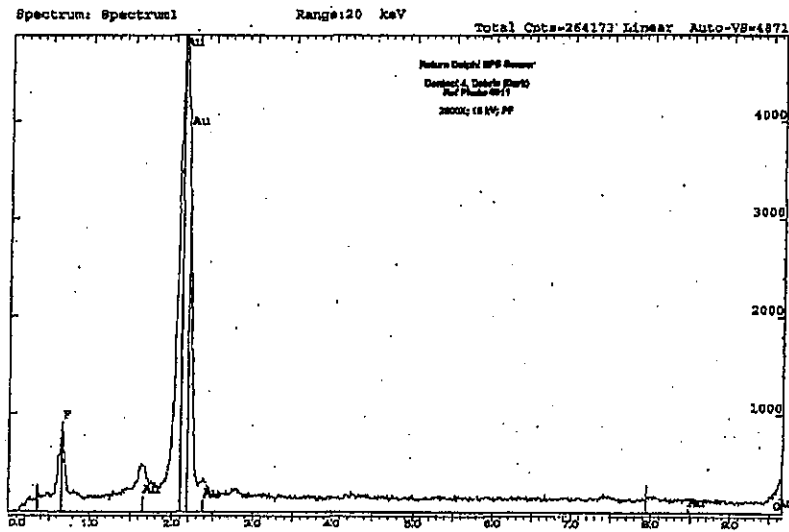
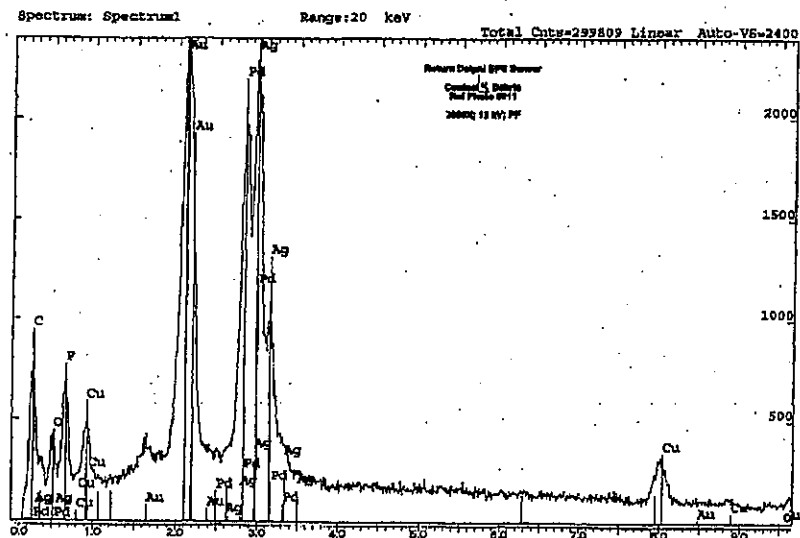
Figures 14a-c indicates that the compacted debris found on the leading and trailing edges of the contacts as having somewhat variable chemistry, from the highly conductive (14a) to the highly resistive (14c). Although it is possible that a noise spike could occur if this compacted layer did break free and rotate under the contacts, this would be a random event and not likely tied to a specific geometric location on the ring. Therefore, although the presence of this debris field raises some concern for long term reliability, it does not appear to be the root cause for the noise spikes found on the field returned unit.

Figure 14a X-ray spectrum from one of the larger flakes contained in the wear debris shown in figure 13b

Figure 14b X-ray spectrum from the wear debris shown in figure 13b

Figure 14c X-ray spectrum from the wear debris shown in figure 13b

Figure 14 -X-ray spectra from the flakes and compacted debris found on the wire contacts from the field returned sensor.

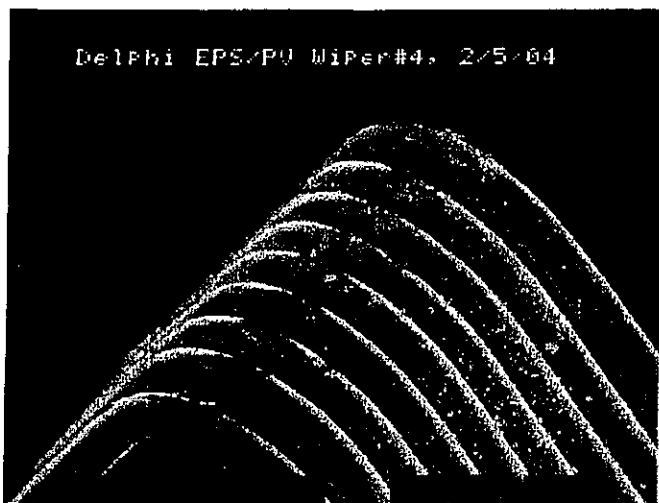
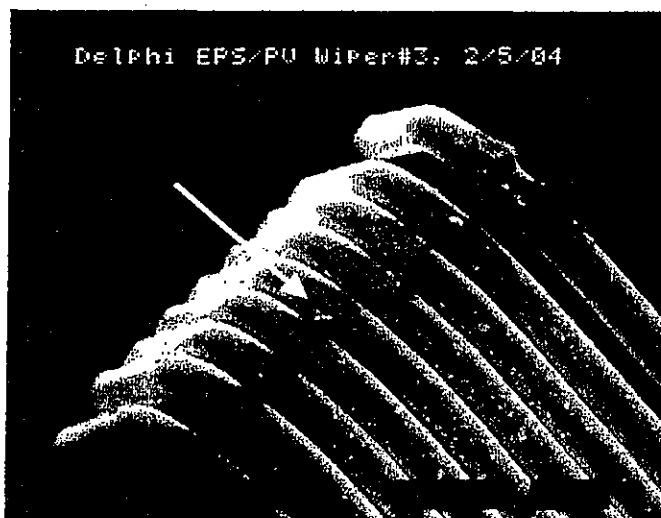
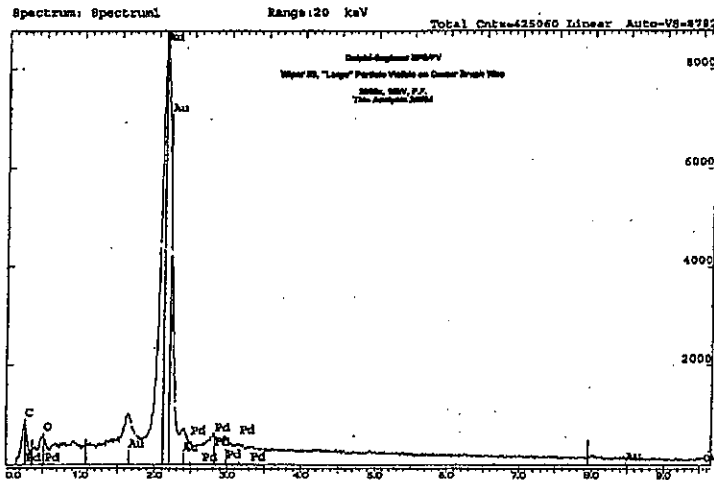
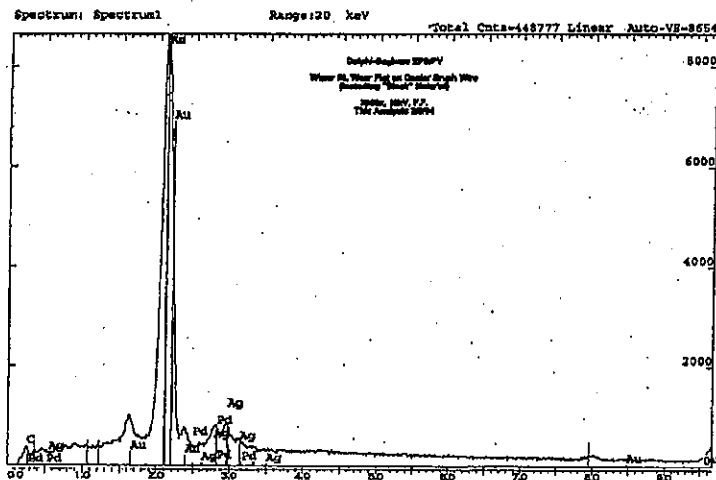
Figure 15a – SEM photomicrograph of contact 4 taken from the PV sensor.

Figure 15b – SEM photomicrograph of contact 3 taken from the PV sensor. White arrow denotes flake analyzed in figure 15d.

Figure 15c - X-ray spectrum from the wear flat found on contact 3 shown in figure 15b.

Figure 15d - X-ray spectrum from the flake found on contact 3 highlighted by the arrow in figure 15b.

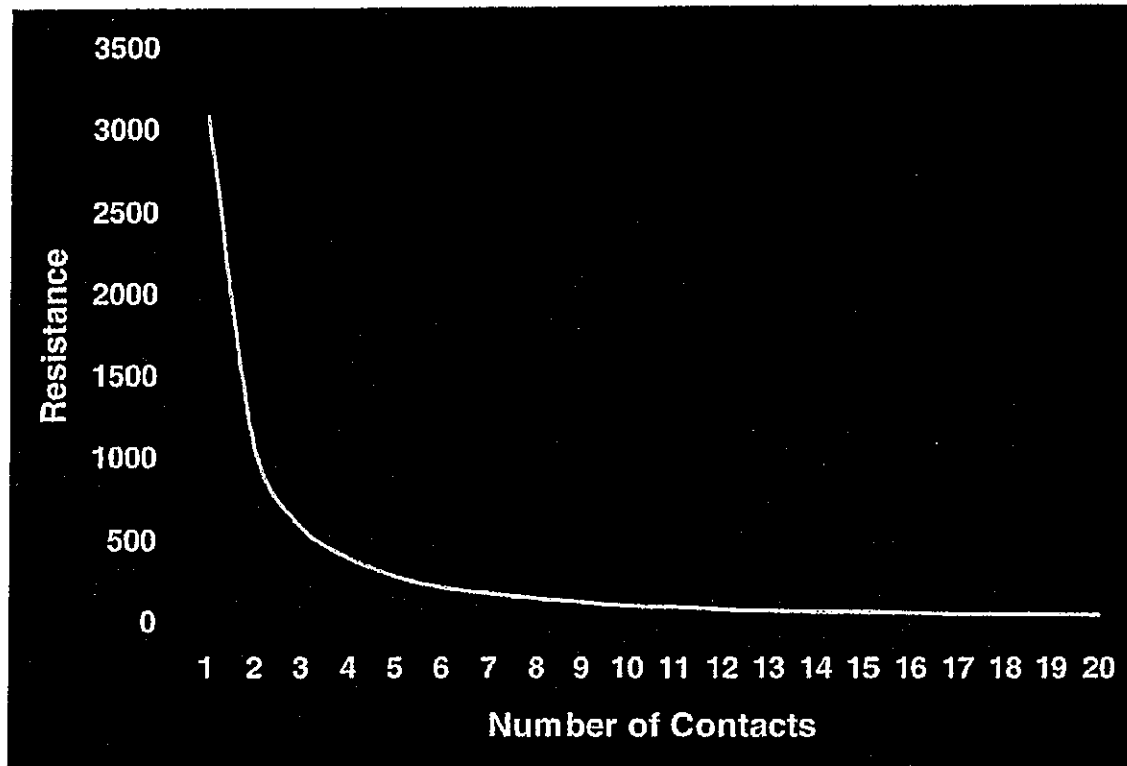
**Figure 18**  
Plot of resultant contact resistance vs  
the number of points of contact

As noted earlier, the use of a multi-point design concept is recommended for applications requiring very low noise levels. Figure 18, (a plot of the net resistance versus the number of fingers) shows the knee of the curve to be in the range of 3-7 contacts. Although this curve is based on a uniform tarnish film of 2 ohms under each finger, the relative shape will not change with resistance. From this curve, it is also evident that adding more than nine fingers will not significantly improve the overall noise response. The only advantage of more fingers is that it increases the overall coverage area of the contact, thereby reducing the chances of a single particle or debris field covering all the contact points. This slight improvement is generally outweighed by the increased difficulty associated with manufacturing and handling a contact with ten or more fingers.

Calculations assume only a uniform surface film of 2000 milliohms  
(absolute values will change with resistive strength of the film but  
the shape of the curve and the position of the "knee" of the curve are  
independent of the film strength)

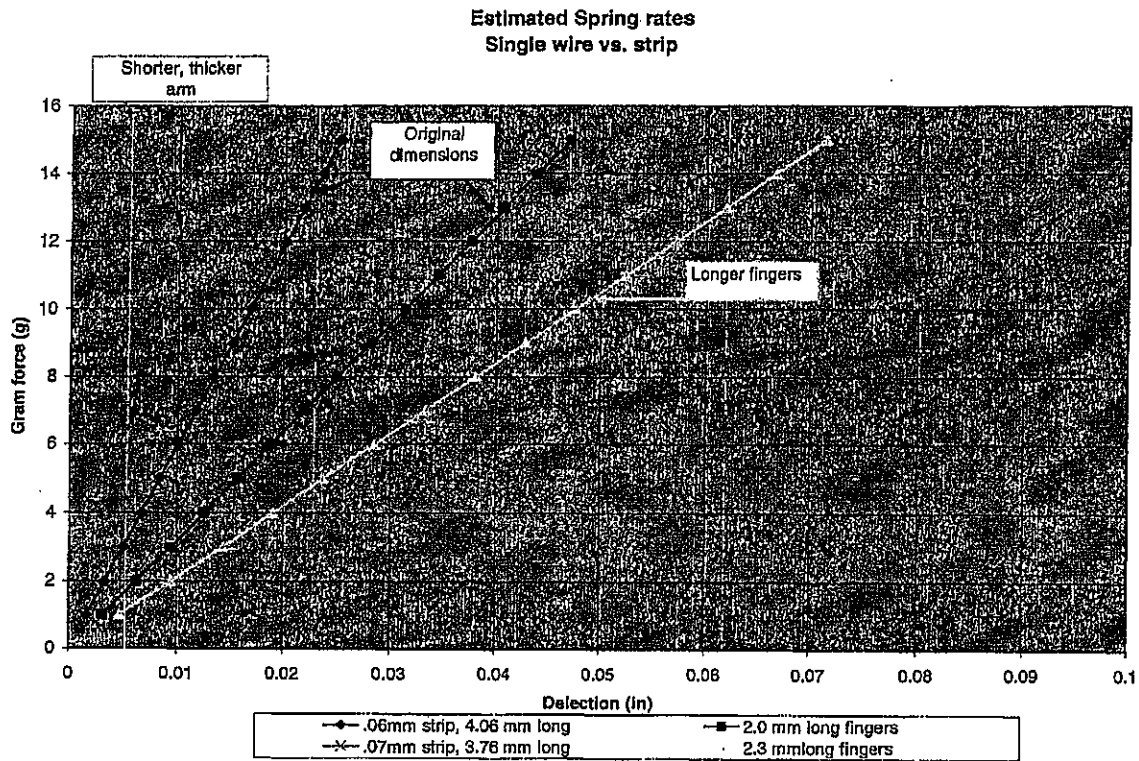
**Figure 19**

An example of this is shown in figure 19, which plots the gram force vs. deflection for some simplified versions of the arm and a single wire finger. The original dimensions for the existing arm design were estimated by an isolated rectangle of BeCu .06mm thick, 4.06 mm long, and 2mm wide (modulus = 13,500 Kg/mm<sup>2</sup> as per Brush Wellman data sheets) The finger is estimated as an isolated Pallney 7 wire .087mm dia. by 2 mm long. (modulus 12,000 Kg/mm<sup>2</sup> as per material property sheets- Deringer- Ney). As you can see, this over simplified approach shows the arm to have a slightly higher spring rate than the finger. This means that if they were isolated contacts, the finger will first move a small amount until the force generated by the finger is high enough to move the arm. After that point, any additional deflection will be shared by both components. In actual fact, they are mechanically joined by a very stiff welded region composed of the BeCu arm, the wires and the shorting strip.

Idealized spring rate calculations for two simplified cantilever springs that approximate the BeCu spring arm and a single Paliney 7 finger.

Original dimensions shown in dark blue (BeCu spring) and pink (wire)  
Yellow line shows effect of increasing wire length by 0.3mm  
Light blue line show effect for shortening spring by 0.3mm and increasing thickness to 0.07mm

Since the field return sensor demonstrated excessive noise, I would recommend investigating an increase in the overall gram force. I am assuming that the noise spike was created by either lift off or by some foreign debris that was dislodged in transit (so it was not present/visible during our investigation). I would also look to re-balance the force by reducing the spring rate on the fingers- to allow for a higher level of mechanical independence of the individual fingers and increase the spring rate of the arm. There are a number of geometric changes that will accomplish this objective. I would first look to slightly increase the length of the fingers and slightly increase the thickness of the BeCu arm. The exact dimensional shifts will require a stress analysis to ensure that the new design doesn't exceed the yield stress of either material. This is especially true if the new design changes the initial free height or overall deflection to reach the higher gram force levels.

Based on the variation from the actual design, these plots are only meant to provide directional guidance. In that regard, I have also included data for a slightly longer finger (2.3 mm vs. 2 mm, at the same diameter) and a slightly thicker arm shortened to accommodate the extra finger length (.07mm thick and 3.76mm long vs. .06mm thick by 4.06mm long for the original). Both changes act to increase the difference between the finger and arm, providing more independent motion for the finger and less likely that the motion of one finger will lift the entire contact. Again, I have not calculated the resultant stress levels or total gram force for the new dimensions- they are meant only to provide directional guidance and not as specific dimensional recommendations. As noted early, any changes on the contact dimensions should be tested to evaluate the balance between noise and wear. It should also be noted that if the current supplier is not capable of maintaining the consistency of the Au plate found on the PV samples, a protective covering over the Au should be considered. This would also require proper validation testing.
